## Implementation Guidance for the Control of Undesirable Vegetation on Dredged Material

**PURPOSE:** The purpose of this technical note is to provide guidance for implementing selected management practices to control undesirable vegetation on dredged material.

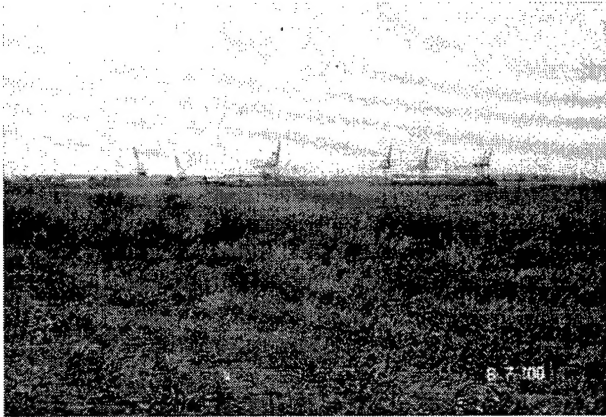
Figure 1. Phragmites (*Phragmites communis*) covering Eagle Island CDF, Wilmington, NC

**Wilmington, NC.** The Eagle Island CDF was totally covered with 3-m- (10-ft-) tall common reed (Figure 1). The aboveground stems and tops (3 m (10 ft) tall) were cut with a box blade and placed into piles for burning or composting. Because burning can contribute to poor air quality, composting

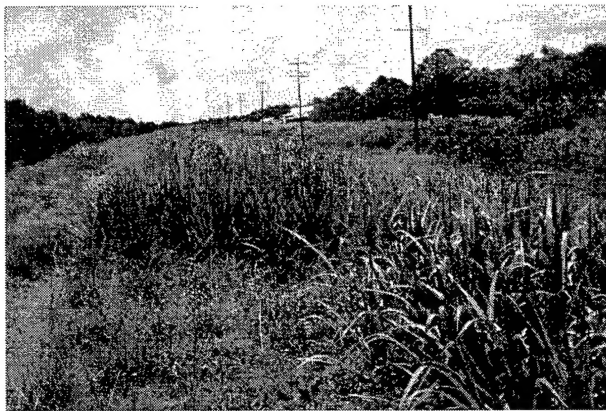
Figure 3. Napier grass (*Pennisetum purpureum*) on the Herbert Hoover Dike around Lake Okeechobee, FL

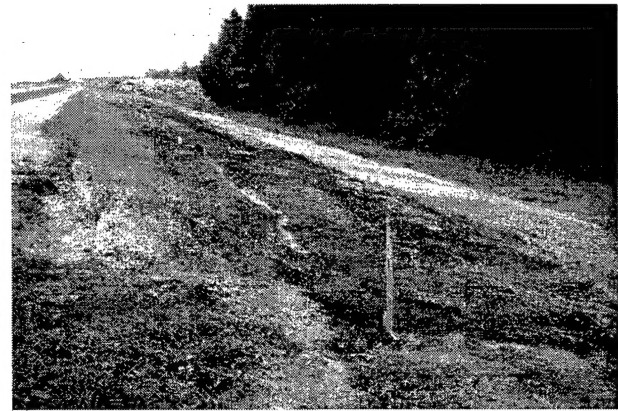
Figure 4. Incorporation of yardwaste and N-Viro biosolids into sandy, droughty dredged material on Herbert Hoover Dike (Jun 95)

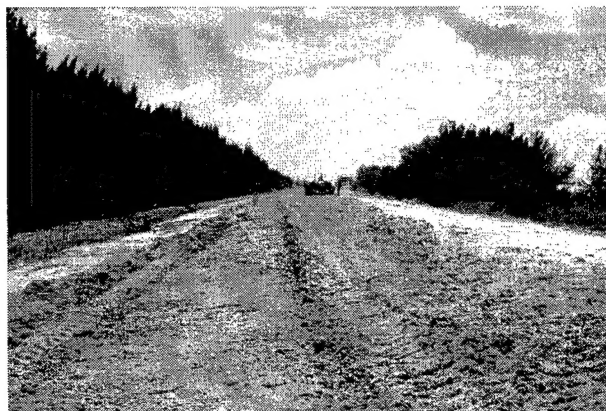
Figure 5. Incorporation of bagasse and N-Viro biosolids into sandy, droughty dredged material on Herbert Hoover Dike (Jun 95)

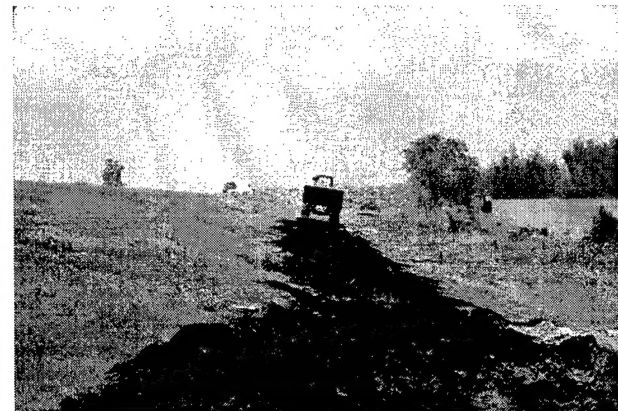
Figure 6. Melaleuca compost applied to the Herbert Hoover dike dredged material and incorporated by disking

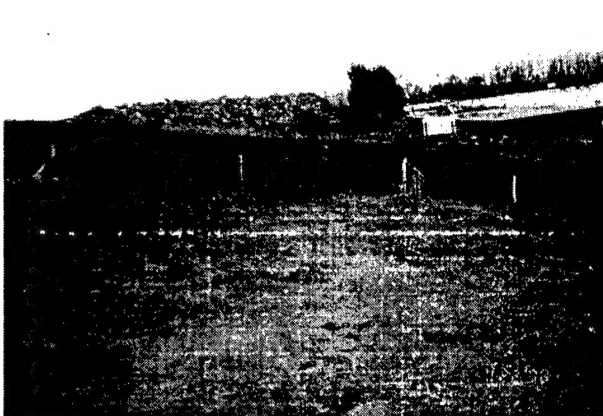
Figure 8. Lake debris in combination with N-Viro biosolids (left side of photo) and Bionsoil biosolids (right side of photo) incorporated by disking

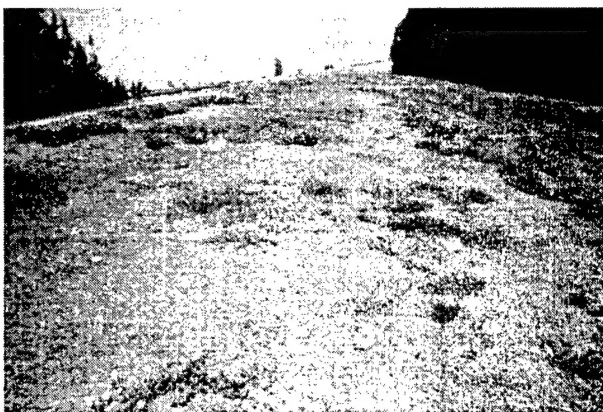
Figure 10. Planted desirable vegetation established on the bagasse and N-Viro biosolids demonstration plots (Jun 96)

all demonstration plots. The bagasse and N-Viro biosolids plots showed the least amount of undesirable vegetation and the best growth of planted desirable vegetation (Figure 10). After 2 years of herbicide wiping, Spanish needle continued to reestablish from the massive seed bank collected over the years (Figures 11 and 12). However, perennial peanut became established on the bagasse and N-Viro plots despite the continuous regrowth of Spanish needle (Figure 13).

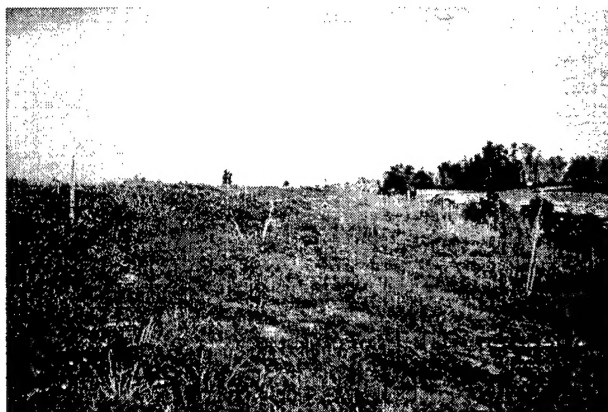
Figure 11. Vegetative cover on yardwaste and N-Viro biosolids demonstration plots (Sep 98)

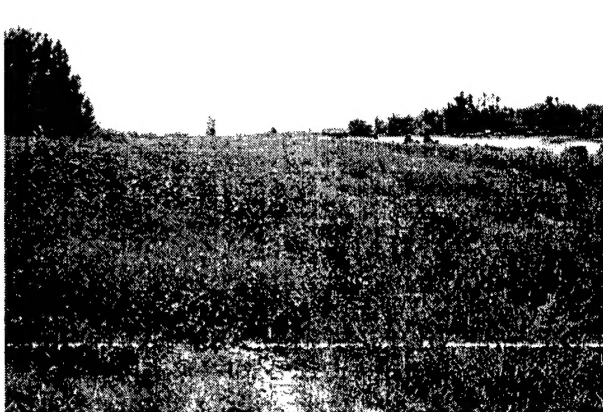
Figure 12. Vegetative cover on bagasse and N-Viro biosolids demonstration plots (Sep 98)

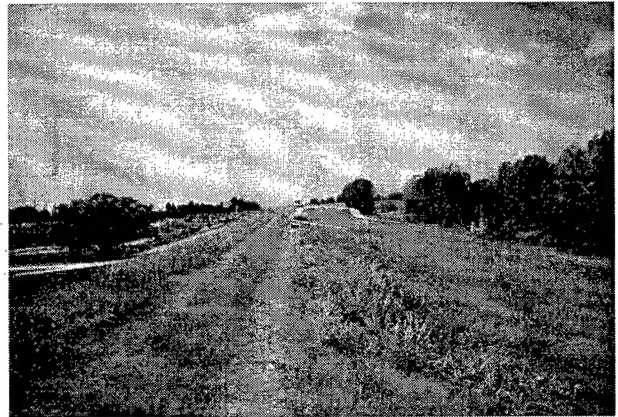
Figure 14. Herbicide wiping of undesirable vegetation on Herbert Hoover Dike dredged material at South Bay (Apr 96)

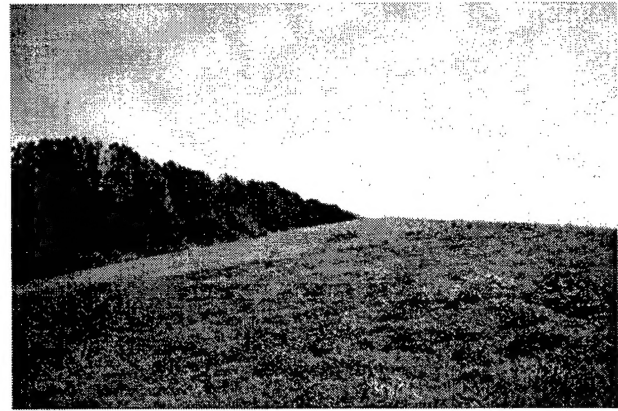
Figure 16. Less napier grass and more Spanish needle 1 month after wiping (May 96)

In areas of predominately napier grass, four wipings (Figures 16 and 17) were required to almost eliminate that plant. However, as soon as the napier grass disappeared, Spanish needle covered the area (Figure 18). Two additional wipings of  $2.3 \times 10^2$  ml/ha (32 oz/acre) of Round-Up® herbicide were required to control the Spanish needle vegetation. A combination of wiping and mowing over 2 years was required to control napier grass and Spanish needle vegetation and allow the Bermuda grass and Bahia grass to reestablish on the area. The wiper applicator also successfully controlled undesirable weeds on all of the RSMT demonstration plots established on the dike.

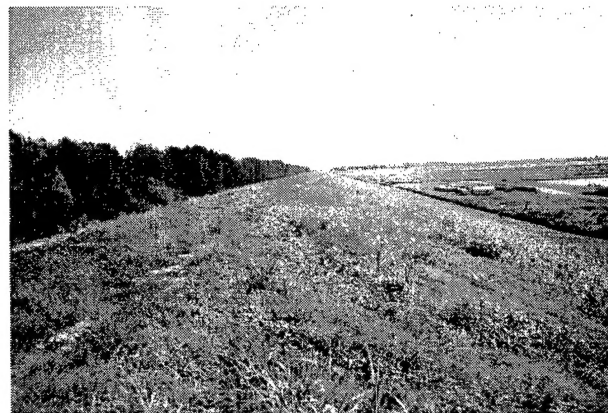
Figure 17. Untreated vegetation on right side of photo (May 96)

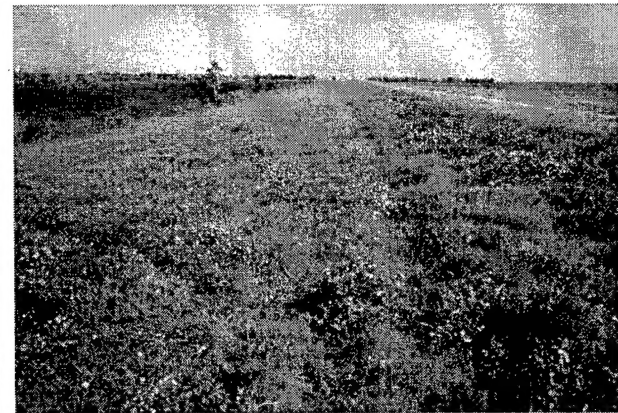
Figure 18. Elimination of napier grass, reduction of Spanish needle, and increased regrowth of Bermuda grass (Dec 99)

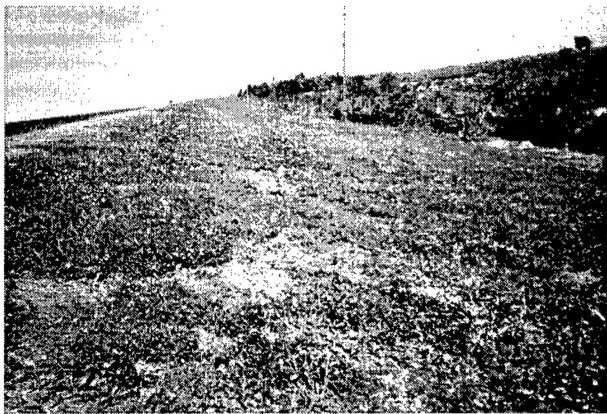
Figure 21. Napier grass eliminated, massive Spanish needle developed (Dec 99)

Other equipment has been developed using the same principles of wiping herbicide on plant leaves versus spraying. A demonstration was conducted in 1999 in cooperation with Monsanto/Weedbug, using newer equipment called the Weedbug®. This equipment, developed in Australia, uses nylon rope instead of the grit panel as the carrier for the herbicide. The saturated rope spins around in a disk-shaped applicator, scratches the plant leaves, and puts herbicide in the scratches for a total kill of the plant. The centrifugal force keeps the ropes saturated equally for a uniform distribution of the herbicide. This is an improvement over the wiper panel, since the tubes on the wiper panel can sometimes get clogged and result in uneven distribution of the herbicide application, producing streaking of the missed plants. These areas are usually eliminated in subsequent wipings. A demonstration area was established near Canal Point, FL, with the Weedbug® applicator (Figures 19 and 20). Again the napier grass was almost totally killed after two wipings and Spanish needle became established (Figure 21).

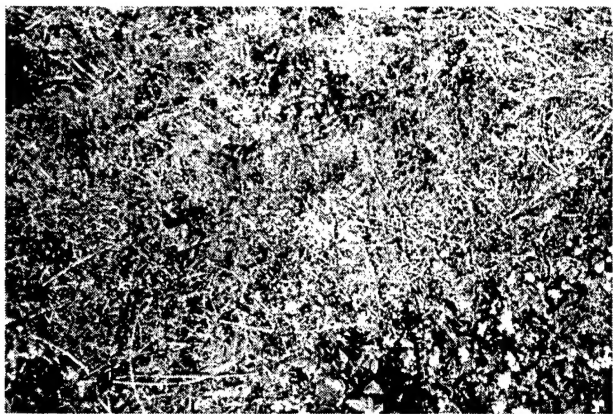
Figure 22. Bermuda grass regrowth among Spanish needle on herbicide-wiped plot (Dec 99)

Additional wiping and mowing were conducted and eventually Bermuda grass recovered (Figure 22) and spread over the area. The untreated control plot was covered with napier grass and Spanish needle (Figure 23). Desirable vegetation is usually present on the dike, but suppressed by the more dominant and aggressive undesirable napier grass. Once the aggressive undesirable vegetation is eliminated, other plant species present get an opportunity to grow. On the Herbert Hoover Dike system, the next plant species to overgrow the areas is Spanish needle. After it is controlled, the more desirable vegetation like Bermuda grass and Bahia grass recover and become dominant. It will take 3 to 4 years of wiper/mowing management to reverse the vegetation progression that has occurred over the past 10 or more years on the Herbert Hoover Dike. A combination of herbicide wiping and reduced fertilizer applications will return the dike system to more desirable vegetation that will be easier to manage. In addition to this weed control program, other technologies such as RSMT are being demonstrated and can improve the long-term fertility of the droughty dike dredged material/soil. The conversion to perennial peanut, which requires only potassium fertilizer and does not require mowing, will substantially reduce fertilizer and mowing costs for vegetative maintenance of this dredged material dike system.

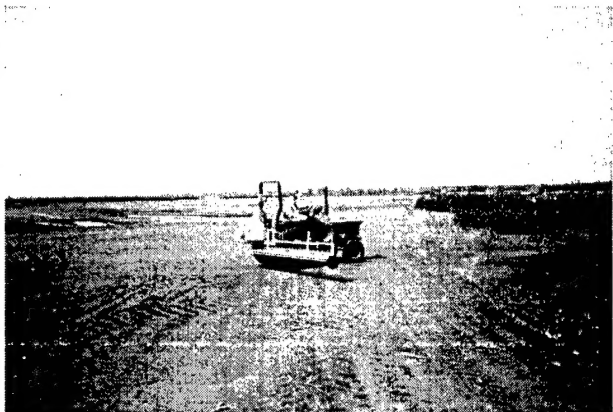
Figure 24. Modified wiper applicator on Eagle Island CDF, Wilmington, NC

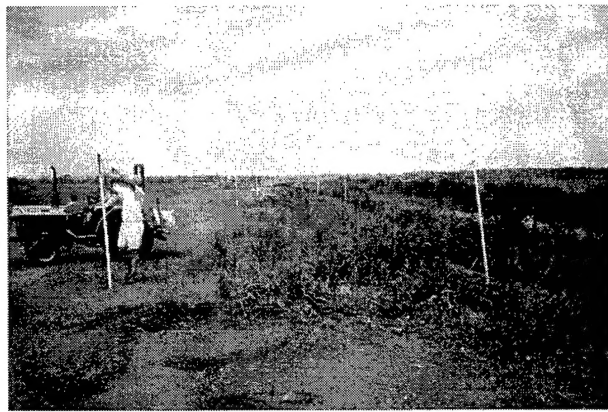
Figure 27. Wiper applying Round-Up® herbicide at a rate of  $2.3 \times 10^2$  ml/ha (32 oz/acre) adjacent to Plot 2 at Eagle Island CDF, NC (23 May 00)

was sought to manage the plant tops. After 6 months, the compost was used as cellulose in a manufactured topsoil according to RSMT. On May 23, 2000, the new regrowth of the *Phragmites* was wiped with a wiper panel on two separate demonstration plots (each 6 by 30 m (20 by 100 ft)) with the glyphosate herbicide Round-Up® at a rate of  $2.3 \times 10^2$  ml/ha (32 oz/acre) once (Figures 24-27) and then a second time after 4 days. Two similar size control (untreated) plots were established for comparison. The plant height was approximately 0.6 m (2 ft) high each time wiping was performed. Effects of the wiping were observed on 24 Jun 2000 (32 days) (Figures 28 and 29). On 5 Jul 2000 (44 days), some new regrowth was observed (Figures 30 and 31). A gallon of ready-to-use Round-Up® was applied by hand spray to spot-spray the green leaves present on each demonstration plot. The concentration of glyphosate was 0.96 percent as the isopropylamine salt. Observations (Figures 32 and 33) were made on 22 Jul 2000 (60 days after the initial wiping and 14 days after hand spot-spray application). Control plots that were not wiped with herbicide were covered with *Phragmites* and other undesirable weeds (Figures 34 and 35). It is expected that the roots/rhizomes of *Phragmites* in these plots will be dead allowing material from that area to be used for RSMT manufactured topsoil or other uses without the interferences caused by *Phragmites*.

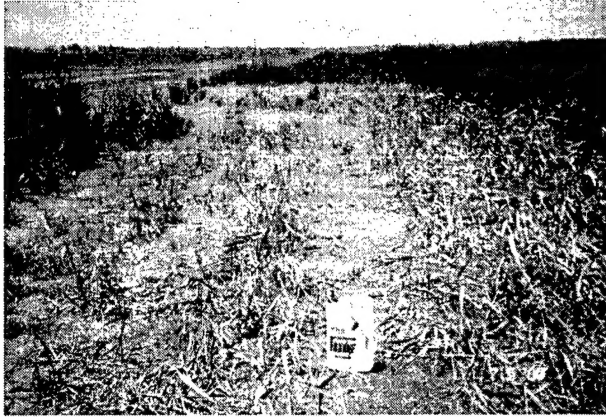
Figure 31. Observation at 43 days of the herbicide-wiped Plot 2 in the foreground with the unwiped control in the background (5 Jul 00)

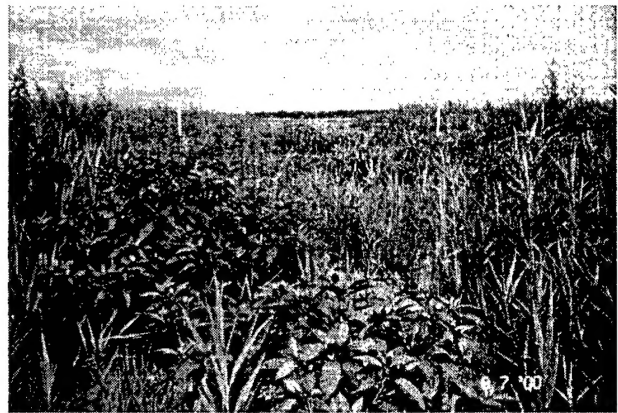
Figure 34. Plot 1 control, unwiped (Jul 00)
